# FRC ON-SITE AIR BAG DEPLOYMENT INVESTIGATION

CASE NO. 90-5

FLEET - 1989 DODGE DAYTONA

LOCATION - NJ

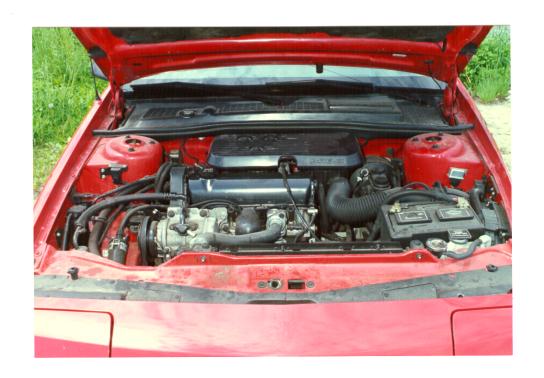
Daytona's Engine Compartment.

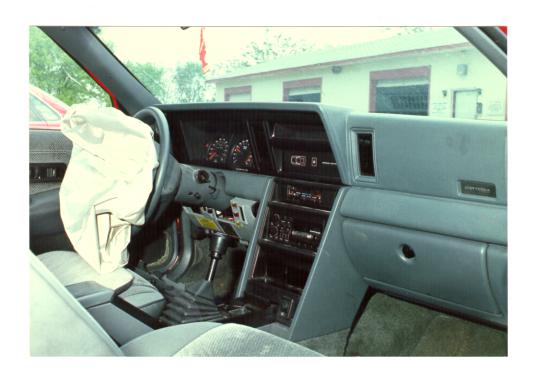
View Across The Interior From The Right Door Area.

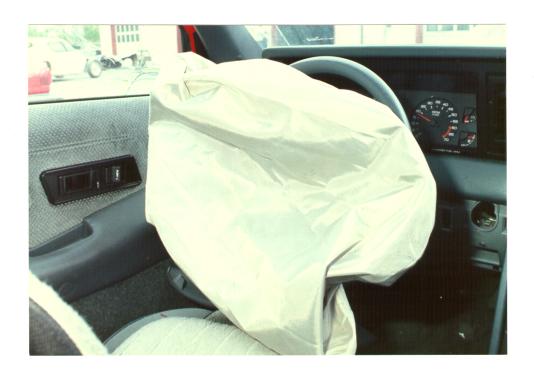
The driver air bag system of the Dodge Daytona was intact during FRC's inspection of the vehicle and there was no visible damage to the components. The investigating police officer noted on his report that "the air bag blew up in the driver's face causing her to lose control and cross over into the opposite lane." The driver did not state this during our interview with her nor did she blame the system as a cause of the accident. She did state that she was looking in her rear view mirror when the accident occurred.

Deployed Driver Air Bag.
